WA-I-387

Brick Church Building

Williamsport Vicinity

INVENTORY FORM FOR STATE HISTORIC SITES SURVEY

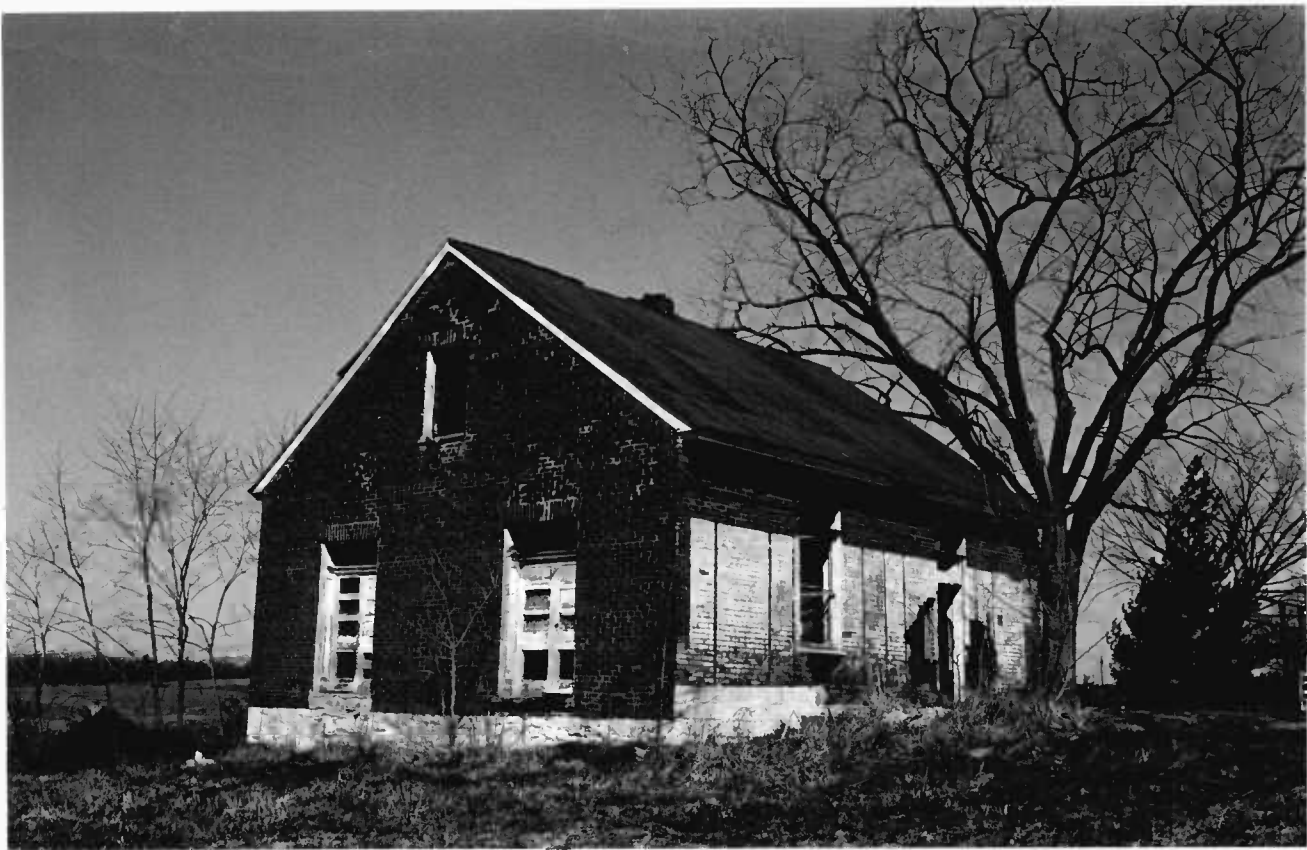
Buck Church Building

This brick building, formerly a church is located along the east side of Walnut Point Road north of Williamsport in Washington County, Maryland. It is situated on a slight slope with its entrance gable end facing south.

The structure is a one story, two bay brick building resting on fieldstone foundations. Its walls display common bonding at all elevations with five courses of stretchers between header rows. Flat arches are present above the doors and windows.

The openings have narrow casings finished with a bead at the inside edge. Where bricks have fallen out of the wall at the east elevation, framing can be seen which suggests that a window in this wall was changed to a door. White paint on parts of the east elevation suggests that a porch or addition extended along this wall at one time. Main entrances are in the south end wall. They appear identical and are placed side by side. Each opening has double four panel doors topped with a broad transom.

The roof is sheathed with sheet metal and terminates with barge boards set directly against the end walls. Part of a brick chimney remains near the center of the roof ridge.

The church is in ruined or deteriorated condition and stands on a tract containing 40.649 acres upon which also is located a set of farm buildings described in survey form WA-I-386.
